*Fitted with the EPIC diesel fuel injection pump*

**13B** DIFFICULT TO START, ENGINE HESITATION, WARNING LIGHT ILLUMINATION

# EPIC INJECTION PUMP

## Repairing the rotor sensor

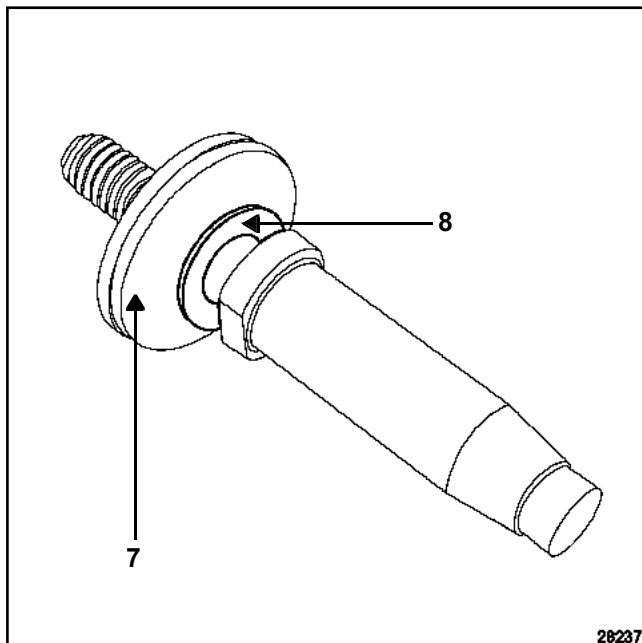
- Faulty rotor sensor inside the EPIC pump.

- Addition of a shim between the rotor sensor core and the pump casing to compensate for the deviation in reading the rotor sensor position.

7 – Original shim(s)

8 – Special shim

- Remove the 2 original shims from the core.
- Fit the special **0.25 mm** shim.
- Refit the original shim(s).

- Refit the core of the rotor sensor whilst holding the shims.

- Screw in the core of the rotor sensor completely by hand.
- Tighten it a quarter of a turn using the tool.

Tightening torque of the core: **1.6 N.m**
