# Intake Manifold/Electric Drive Module

## Possible fault cause and replacement

Vehicle:	Product:	Intake manifold	Electric drive module
Opel Astra H, Vectra C, Signum with 1.9 l CDTi engine (Z19DTH)	PIERBURG No.:	<b>7.00373.12.0</b>	<b>7.00521.14.0</b>
	Replacement for:	7.00373.10.0/ 7.01860.00.0	7.00521.00.0/11.0
	O.E. No.*):	58 50 119/93179055	8 50 440/93183260

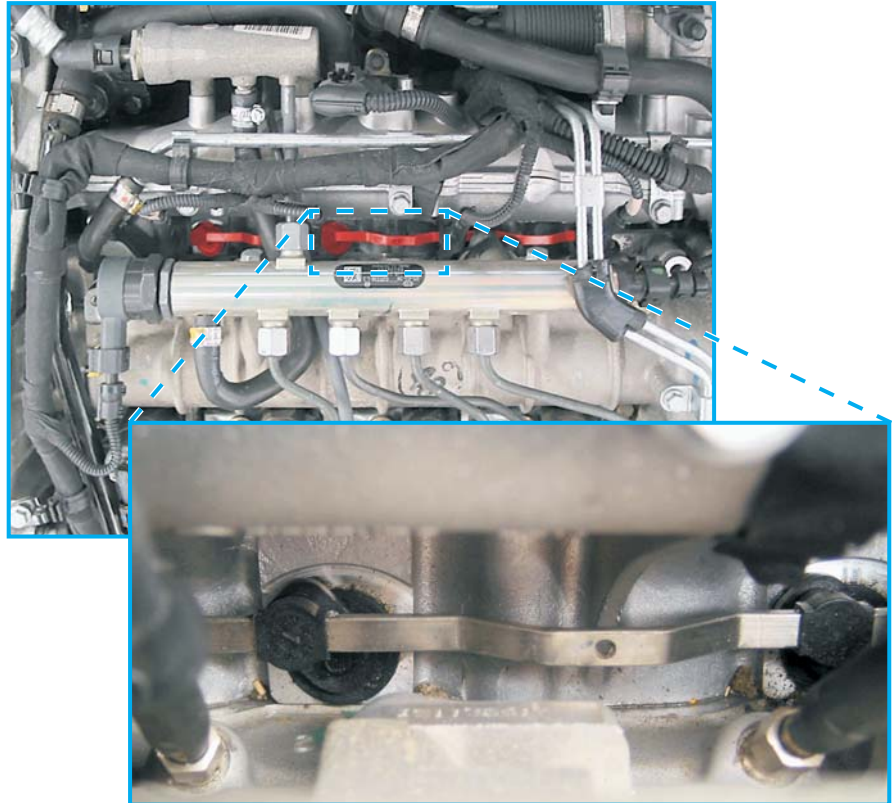
For this reason malfunctions at the tumble flaps or at the lever the arrangement are sometimes attributed to the drive module.

*Lever arrangement at the intake manifold in the Opel Vectra (top emphasised in red and detailed view)*

- Perform an actuator diagnosis (according to manufacturer's information for the diagnosis unit) of the drive module: if the drive module switches, power supply and drive module are electrically in order.
- Check to ensure that there is a proper link ("lever arrangement") between the drive module and the tumble flaps.
- Check to ensure that the tumble flaps can move freely. The actuating lever must, after being deflected, return to its initial position within a period of 1 to 2 seconds.
- It must not be possible to move the tumble flaps in the axial direction (see figure).

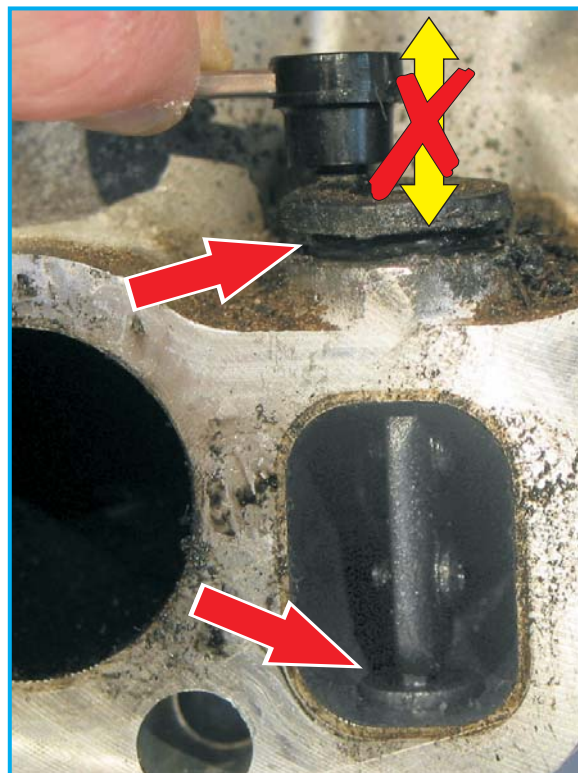
The true fault cause are often worn out, tight tumble flaps in the intake manifold.

The drive module can no longer move the tight tumble flaps and indicates an error.

The cause for these malfunctions are often stiff or sticking tumble flaps.

Deposits or sticking tumble flaps can be caused by very oily intake or charging air. There are many reasons for this.

*Worn out bearings at the tumble flaps*

**For this reason when exchanging the intake manifold, also the electric drive module must be replaced by a new one.**
