## FIAT MULTIPLA REAR SUBFRAME FRONT BUSH REPLACEMENT

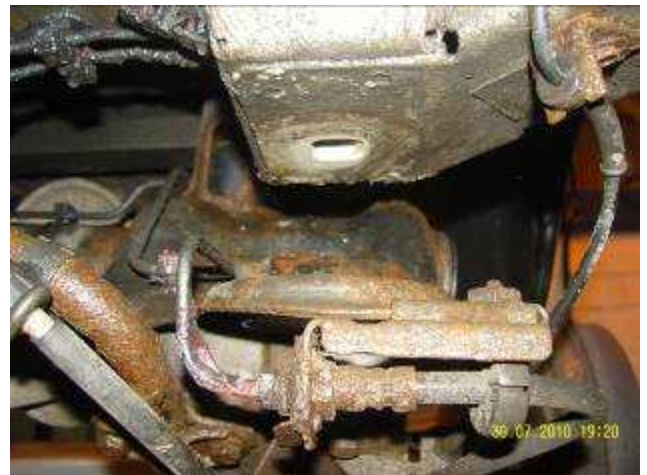
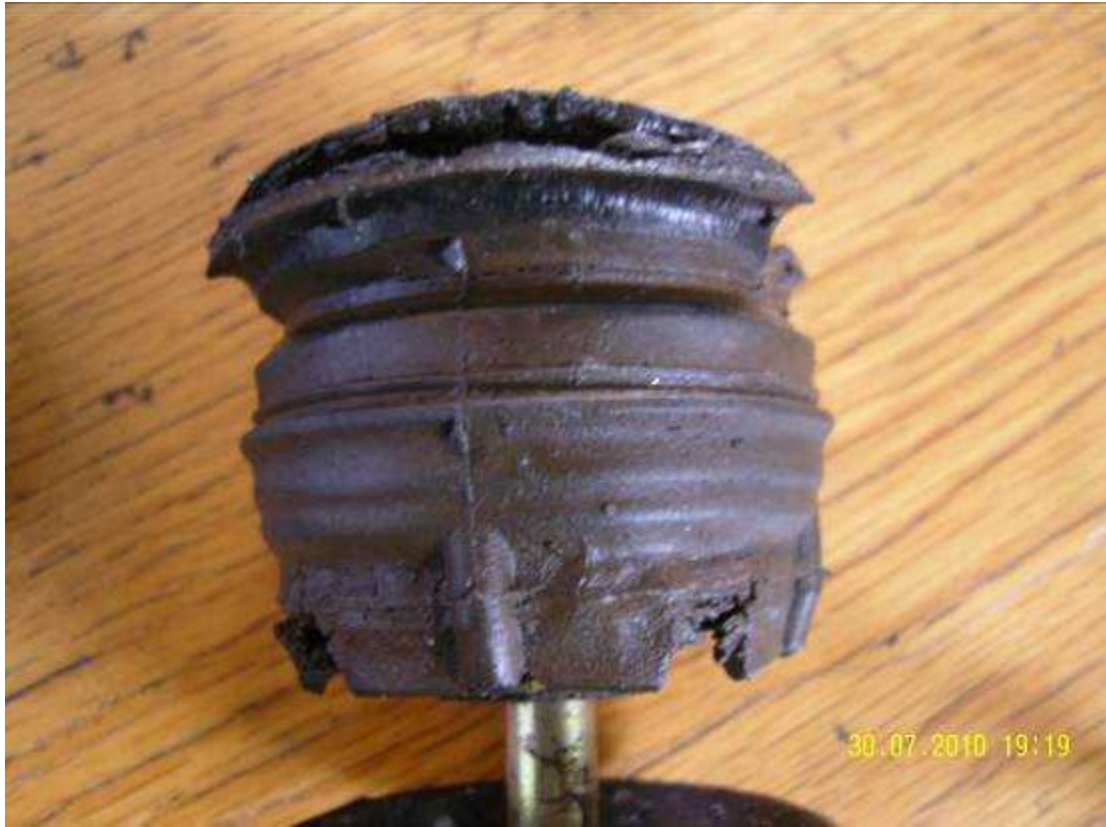
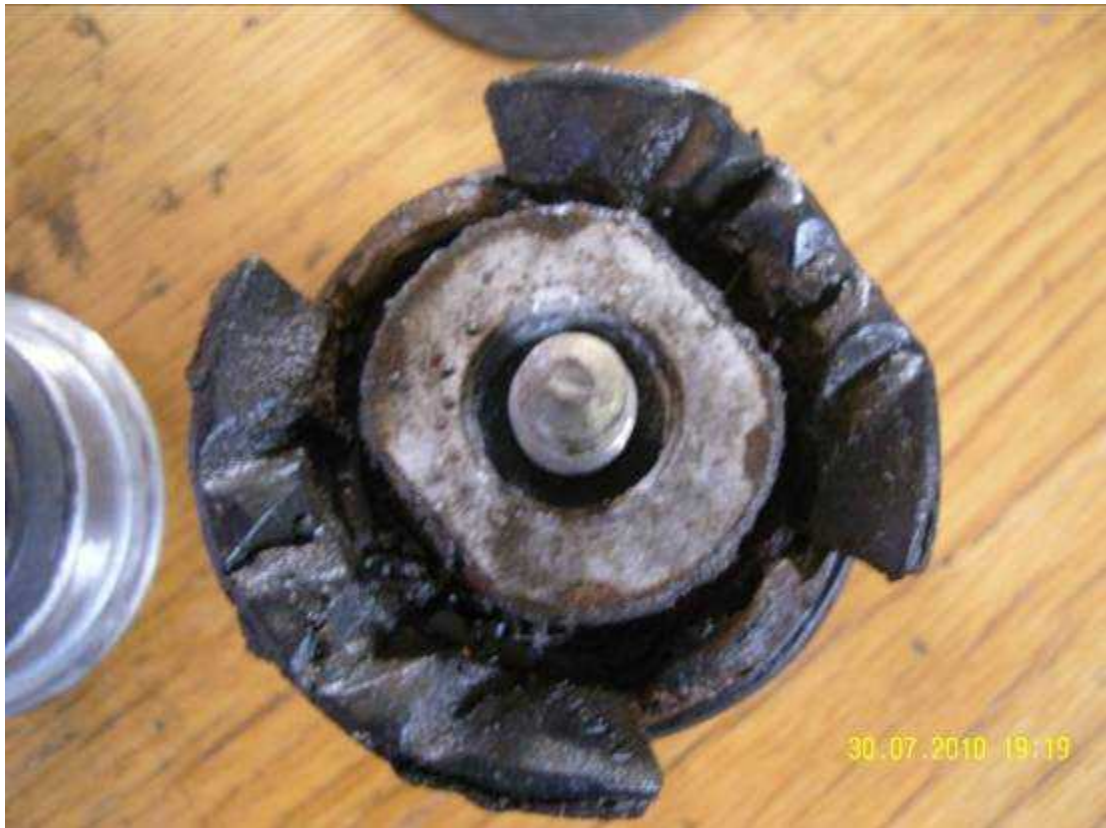
As the front bush bolt is removed the old bush will probably just drop out as it will be worn. You should now have a 12mm bolt, a lower 'cup' washer and a top flat washer that goes between the body and the bush.

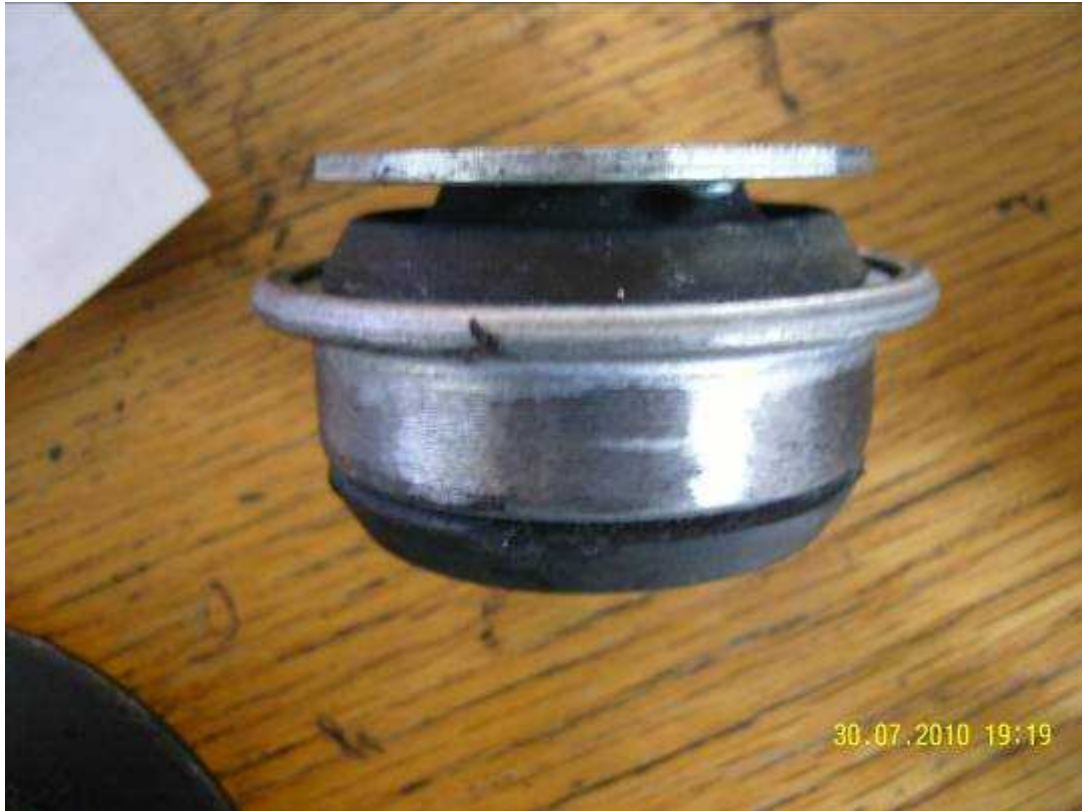
Measurements made with a vernier gauge indicated that the hole in the sub frame measures approx 62mm. The Bravo bush obtained to do the repair measures approx 64mm. Now this bush unlike the old Multipla bush is constructed so that the part of the bush that sits in the sub frame is metal. This means that the bush will be an interference fit which is ideal. But a little on the large side for the hole.

The sub frame hole needs to be 'dressed' with a deburring tool in a drill or a dremel type tool. Basically you need to open the hole in the sub frame by nearly 2mm. what I also did was run the edge of the bush on a bench

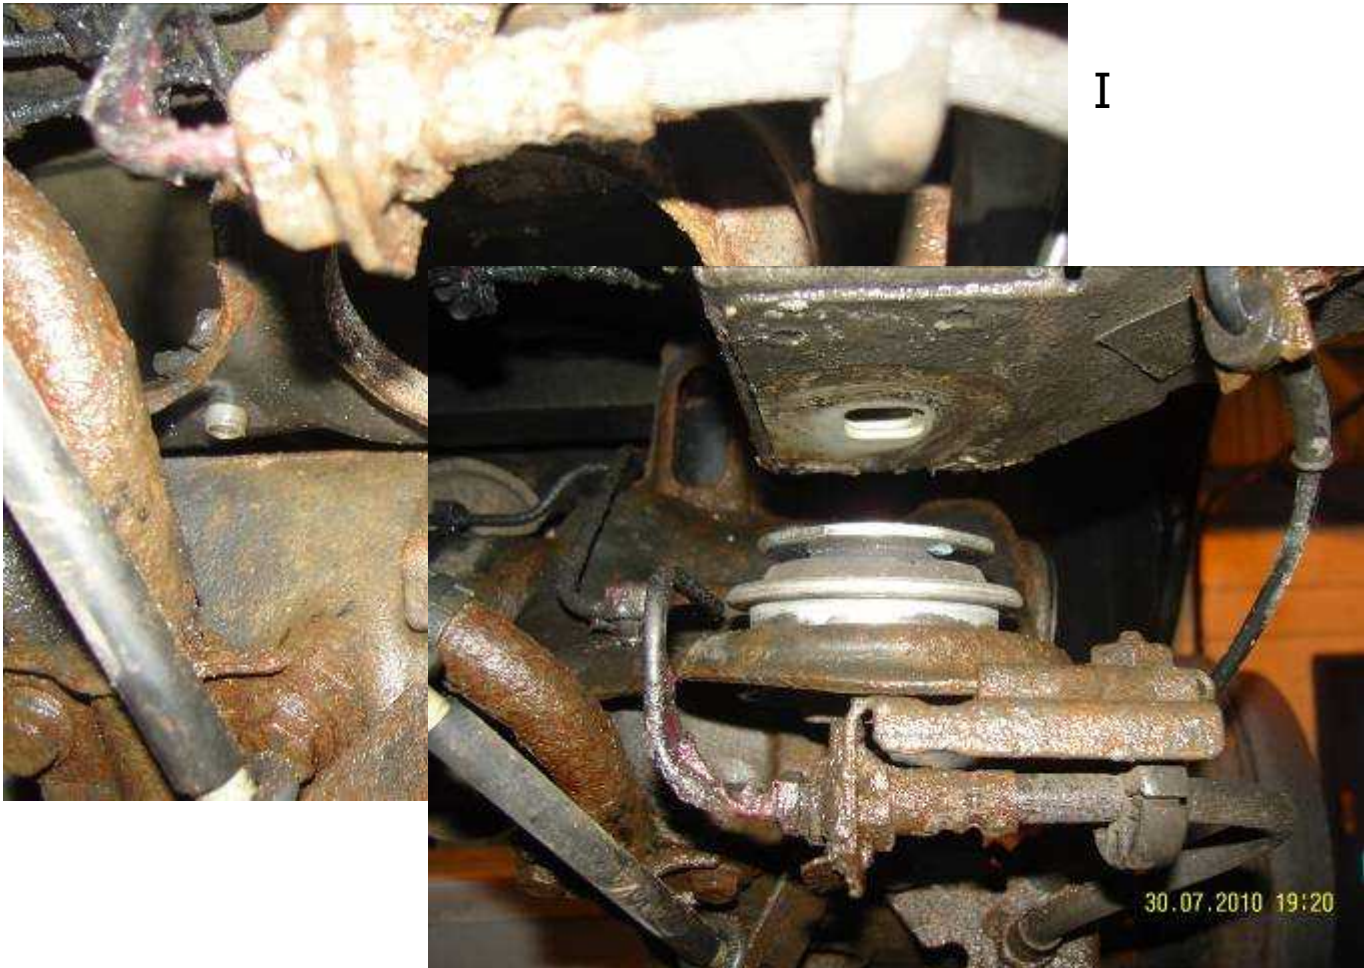
grinder which had the effect of reducing it's diameter but also gave a rough finish which would help to make it grip in the hole in the sub frame.

kept checking the fit of the bush in the sub frame to make sure that I did not take off too much metal.

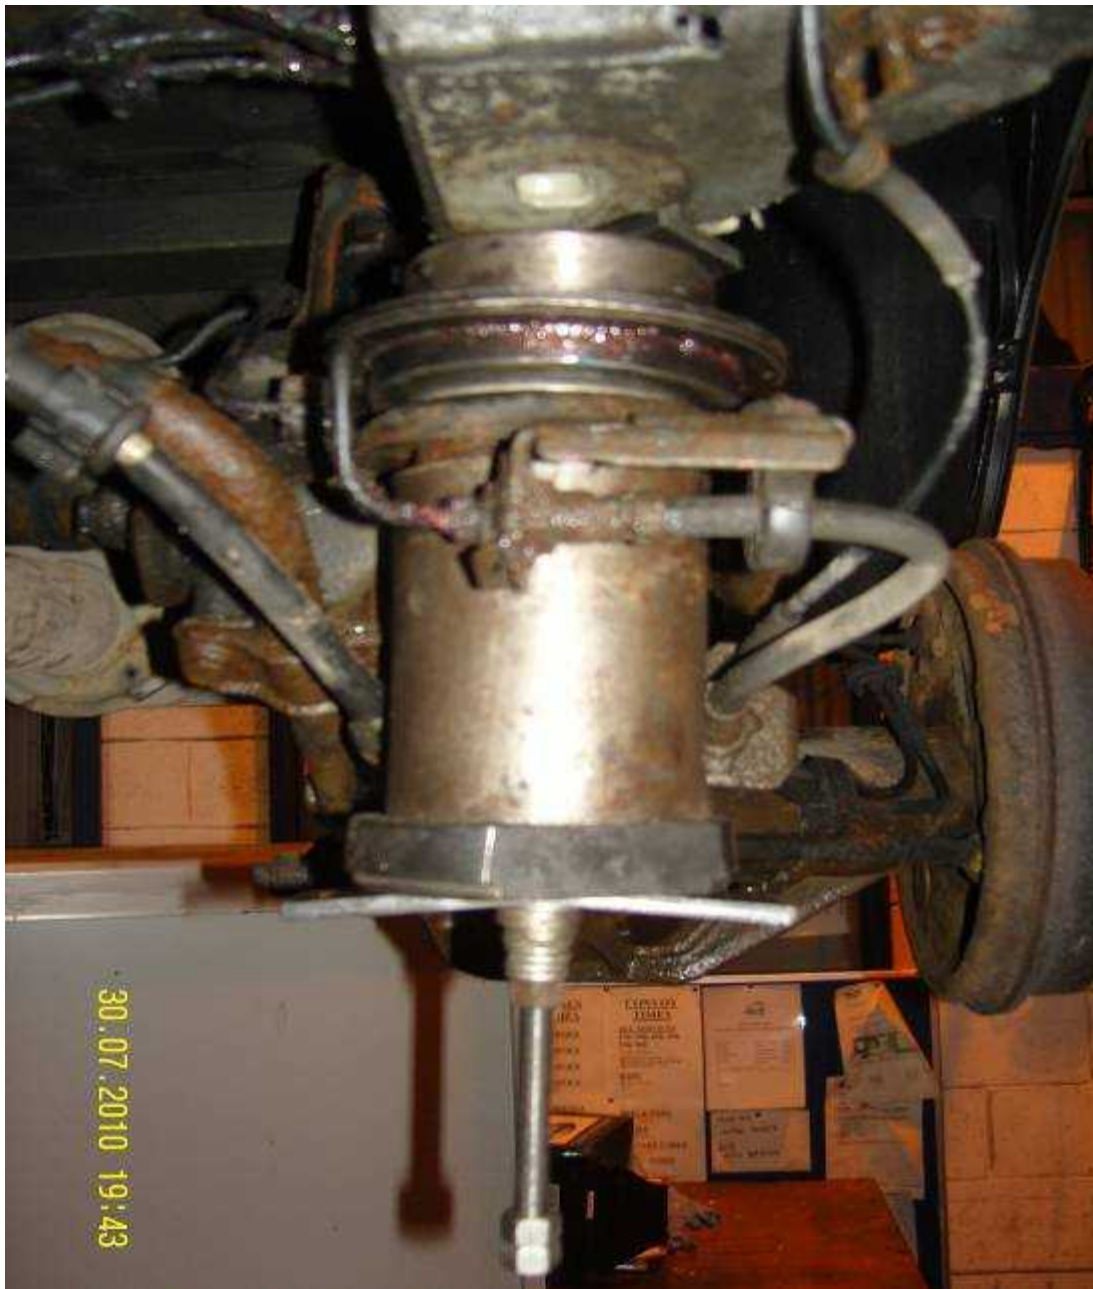
When I felt happy that the sizes were good I assembled the bush into a homemade 'press tool' the bush was a tight fit and again it had to come out to open up the hole in the subframe. Second time around it fitted much better. A small dab of loctite was applied to the mating surfaces to help it bond and it was drawn in as far as it would go.

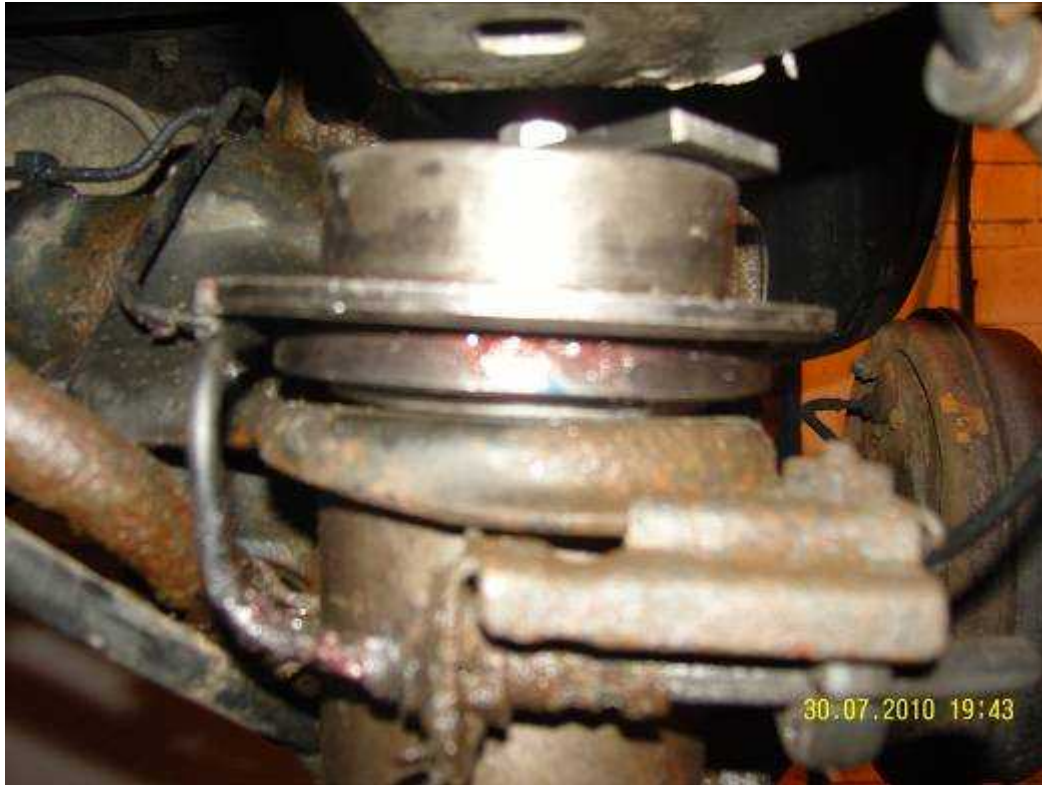
With the tool removed it was apparent that the tool I had made did not get the bush fully into the sub frame. At this point I felt that taking any more from the hole in the sub frame would make the bush too slack in the hole.

I placed a tool over the bush (a large socket would also do the job) and `jacked up the sub frame with the tall stand that I had placed under the sub frame earlier. This sandwiched the bush and tool up to the body. I then knocked the sub frame from underneath with a drift to seat the bush, after each strike I took up the weight of the sub frame with the tall stand. After a few blows the bush was seated flush all the way round.

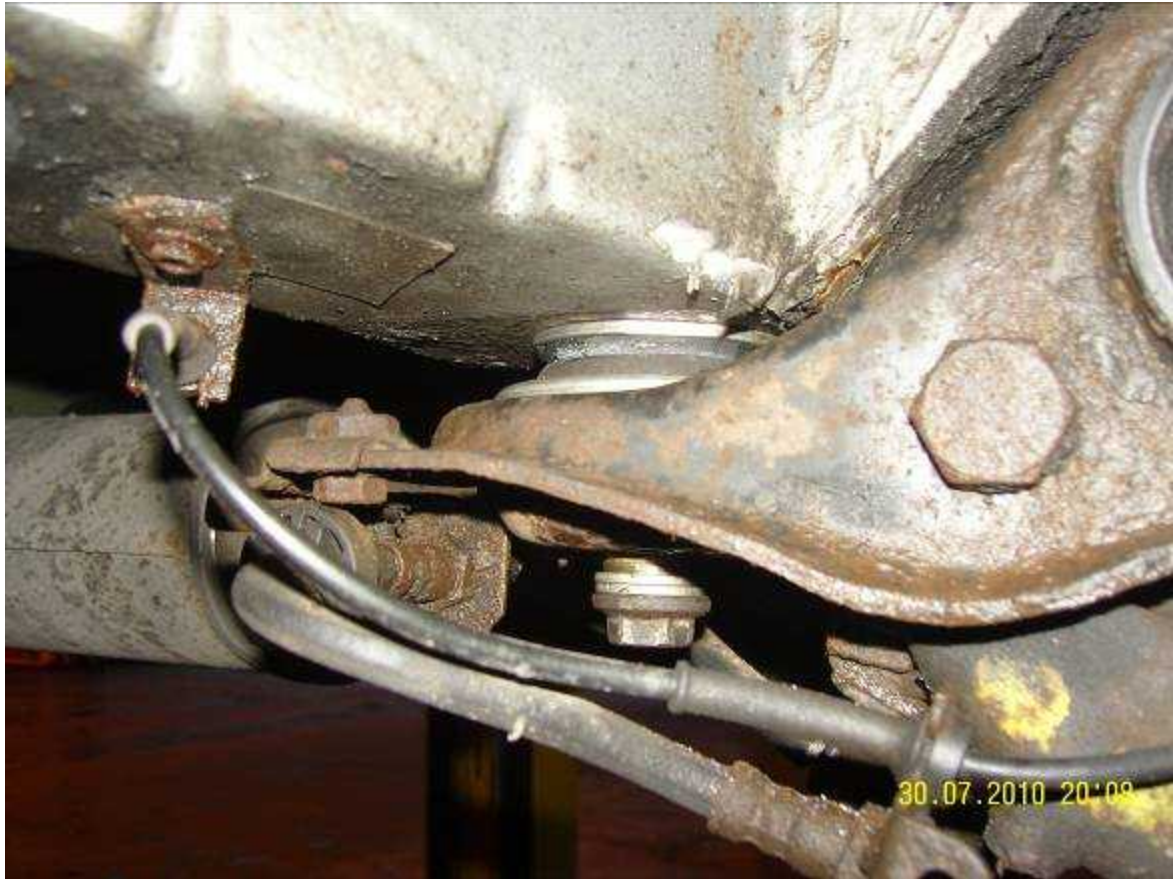
I lowered the stand recovered the tool from the top of the bush and the jacked up the sub frame, copper slipped both sub frame bolts and tightened. I found that the front bolt was now too long as the new bush had the same height from sub frame to body but was a little shorter underneath. As the subframe bolts are metric fine and not that easy to get hold of I packed the bolt with a few washers to take up the extra length. Both bolts tightened, wheels refitted and a

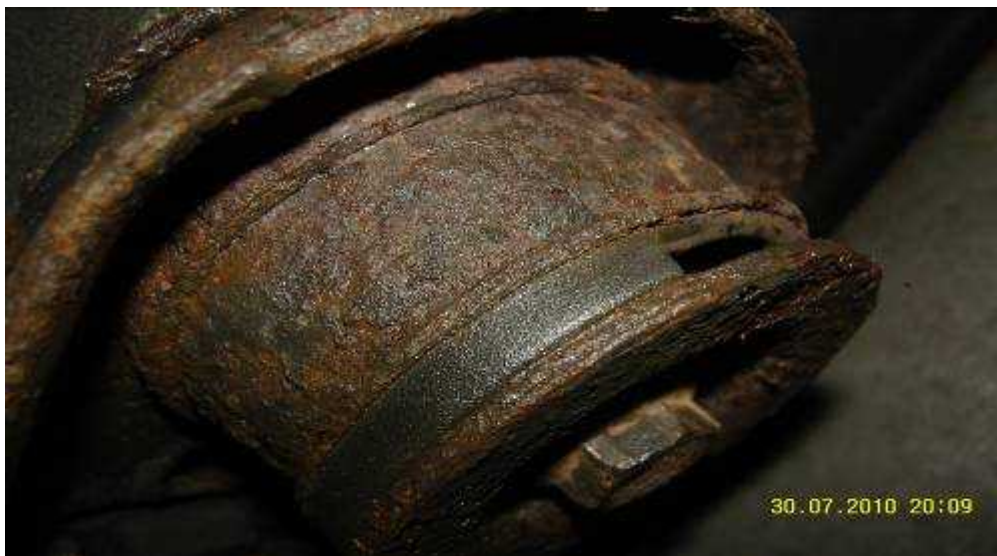
road test confirmed that the repair was a success. I intend To tackle the rear bushes at a later date as these although past their best

were still serviceable.

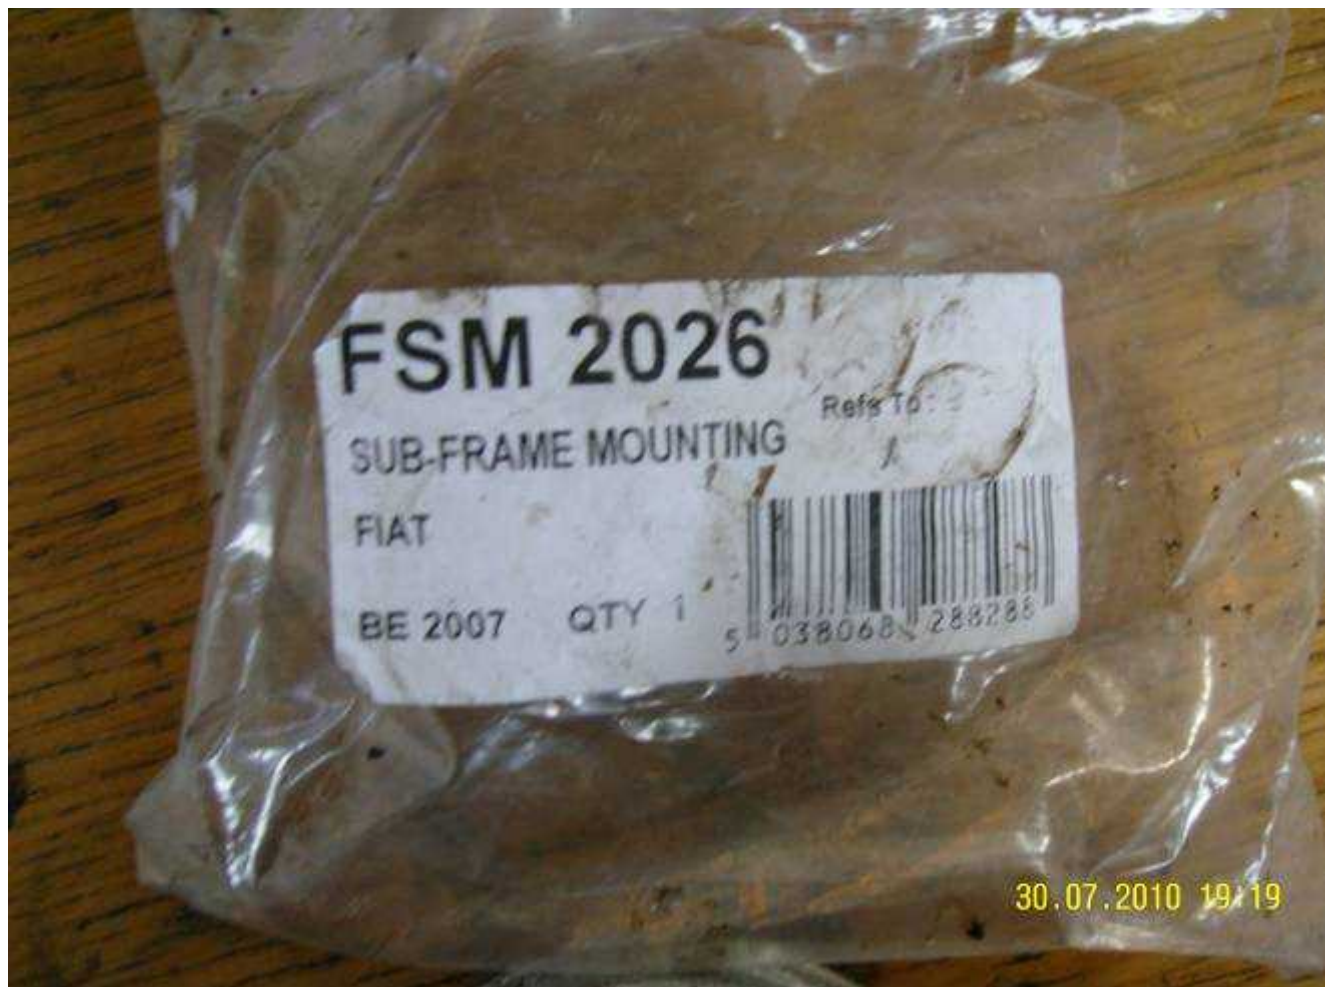
First Line part number FSM2026

Although an aftermarket bush, the Fiat Alfa logo is clearly visible!

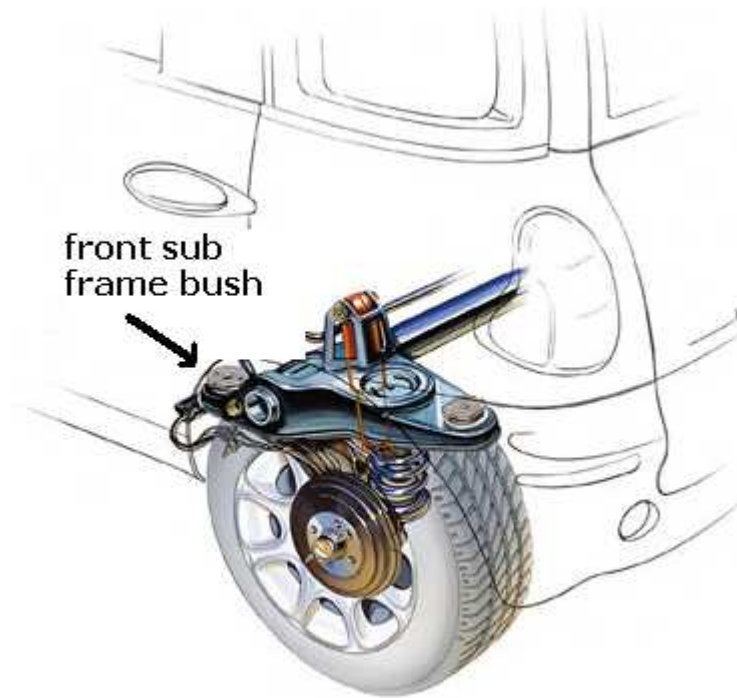
This is the bush that was replaced in this document.

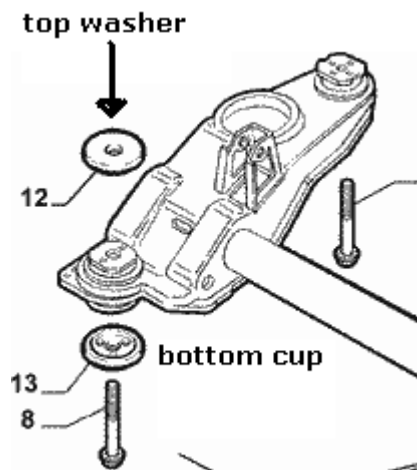
This picture shows the r/h side of the subframe. The top washer is no longer required if you are using the first line bush 2026
