# Intake Manifold/Electric Drive Module

## Possible fault cause and replacement

Vehicle:	Product:	Intake manifold	Electric drive module
Opel Astra H, Vectra C, Signum with 1.9 l CDTi engine (Z19DTH)	PIERBURG No.:	<b>7.00373.12.0</b>	<b>7.00521.14.0</b>
	Replacement for:	7.00373.10.0/ 7.01860.00.0	7.00521.00.0/11.0
	O.E. No.*):	58 50 119/93179055	8 50 440/93183260

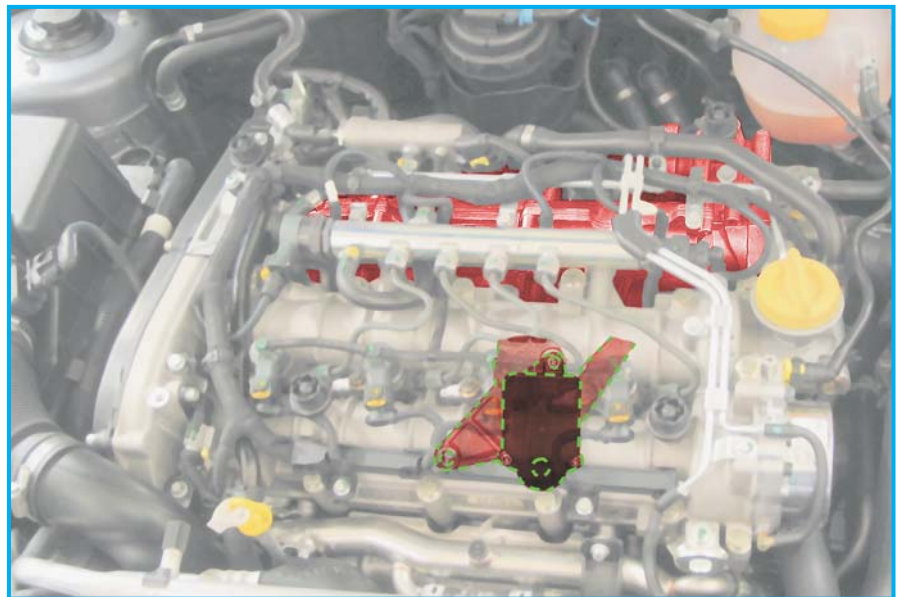
Engine compartment of the Opel Vectra:

The intake manifold with the EGR flap is emphasised in red. The drive module is located, not being visible, "behind the engine" and is only hinted (green dashed line).

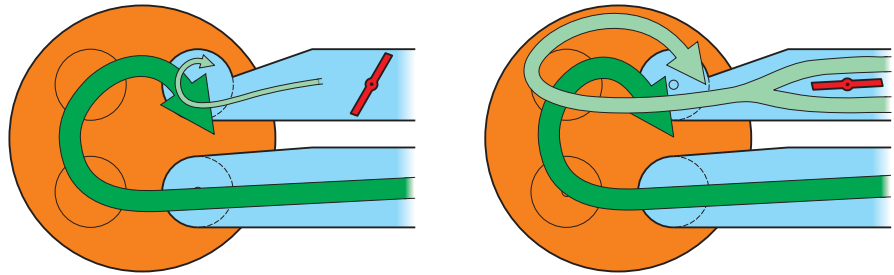
*Operating principle of the tumble flap*

*Low speed:*

*Tumble flap closed, strong swirl*

*High-speed*

*Tumble flap open, high volume flow*

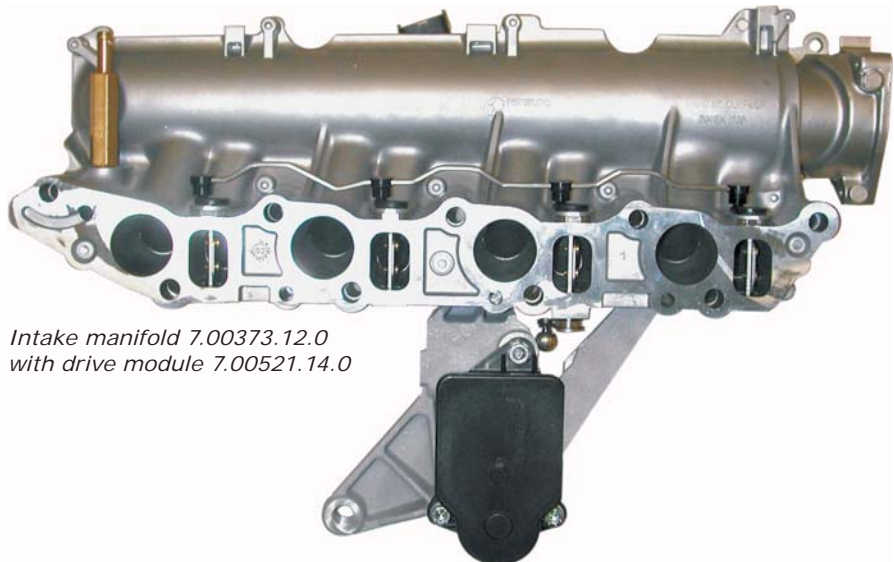
*Intake manifold 7.00373.12.0 with drive module 7.00521.14.0*

The true fault cause are often worn out, tight tumble flaps in the intake manifold.

The drive module can no longer move the tight tumble flaps and indicates an error.

**For this reason when exchanging the intake manifold, also the electric drive module must be replaced by a new one.**

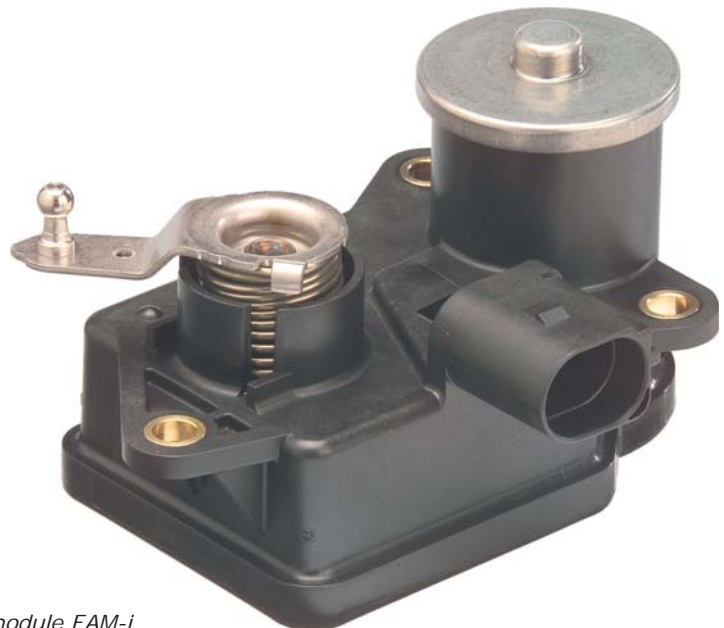
*Electric drive module EAM-i*

An integrated angle sensor acquires the actual position. In case a deviation with respect to the setpoint position is detected, this is then indicated as an error to the engine controller.

The position of the tumble flaps in the intake manifold itself is not acquired. This can only be performed indirectly through the angle position of the drive module.

For this reason malfunctions at the tumble flaps or at the lever the arrangement are sometimes attributed to the drive module.
